**Subject: Annual Inspection Report
Middleton Field Airport
Evergreen, Alabama**

ANNUAL INSPECTION REPORT

MIDDLETON FIELD AIRPORT

EVERGREEN, ALABAMA

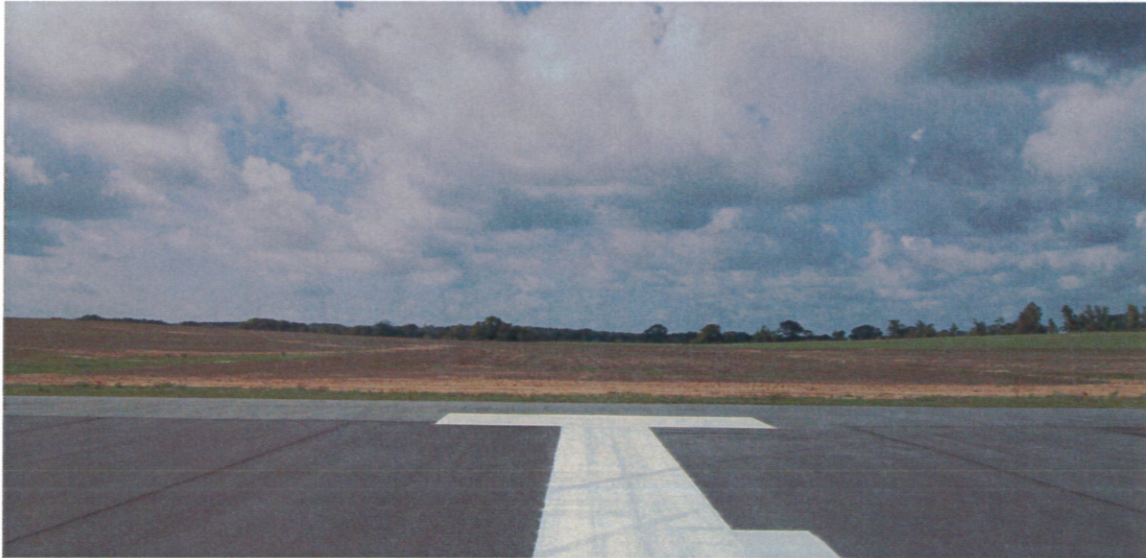
Photo # 1 – Runway Approach/Departure Path

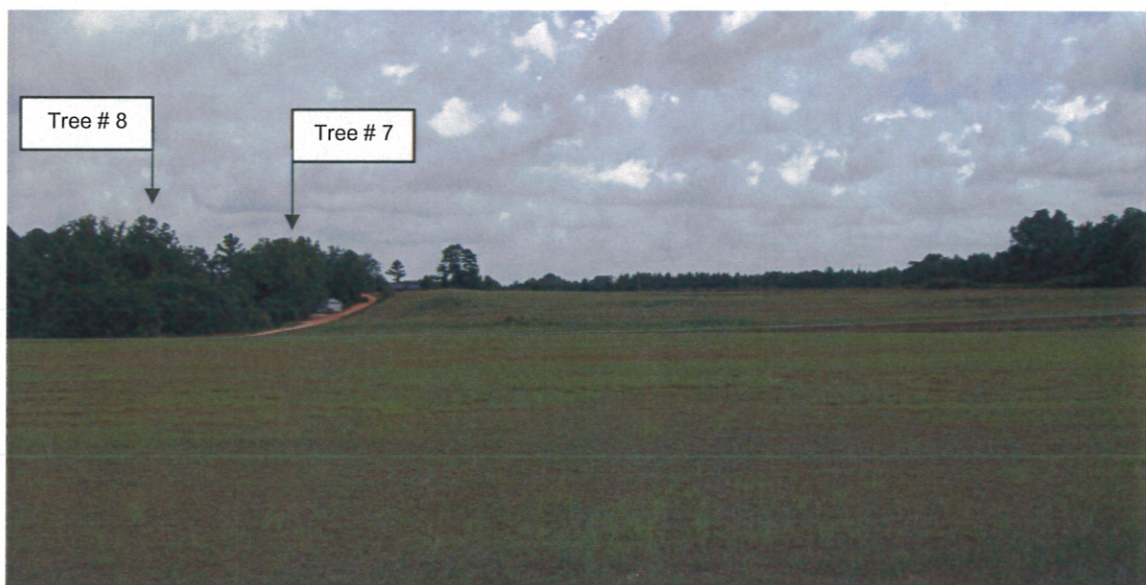
- Runway 1 – No obstructions (See Photo # 1).
- Runway 19 – Trees identified as Tree # 6 and Tree # 7 obstruct the approach slope within the limits of the FAA runway protection zone (See Photo # 2 & Appendix 2).

Photo # 2 – Runway 19 Obstructions

- While these trees are representative of obstructions in the approach departure path of runway 19, 10 and 28 they may not be the only trees that violate the 20:1 approach/departure path, and all obstructions must be removed for an operating license to be issued.

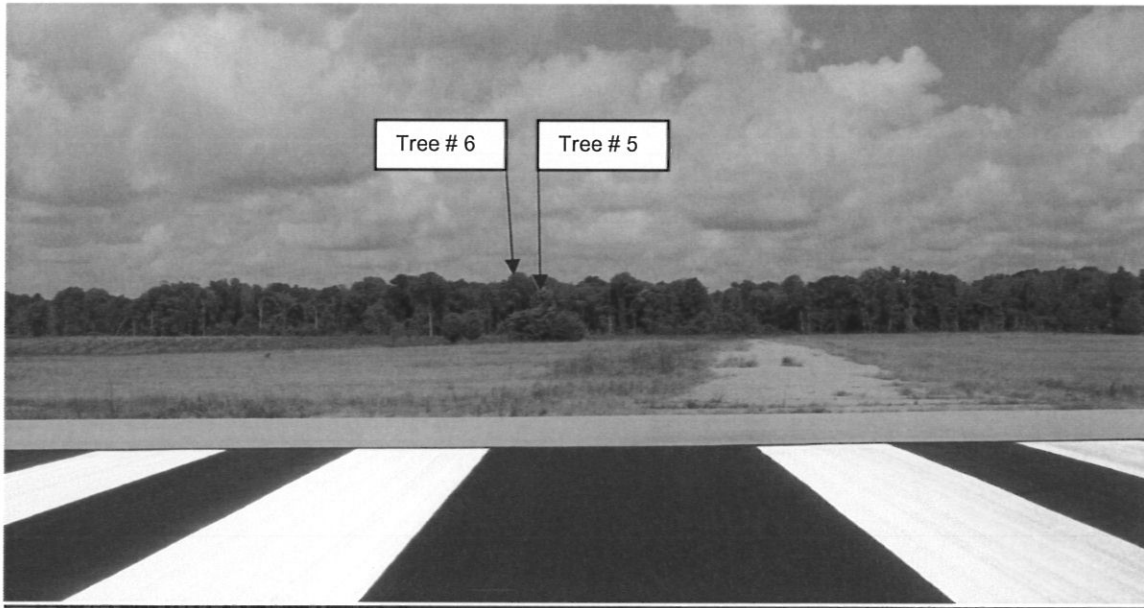
- Runway 10 – Trees identified as Tree # 5 and Tree # 6 obstruct the approach/departure path (See Photo # 3 & Appendix 3).
- Runway 28 – Trees identified as Tree # 2, Tree # 3 and Tree # 4 obstruct the approach/departure path (See Photo # 4 & Appendix 4).

Photo # 3 – Runway 28 Obstructions

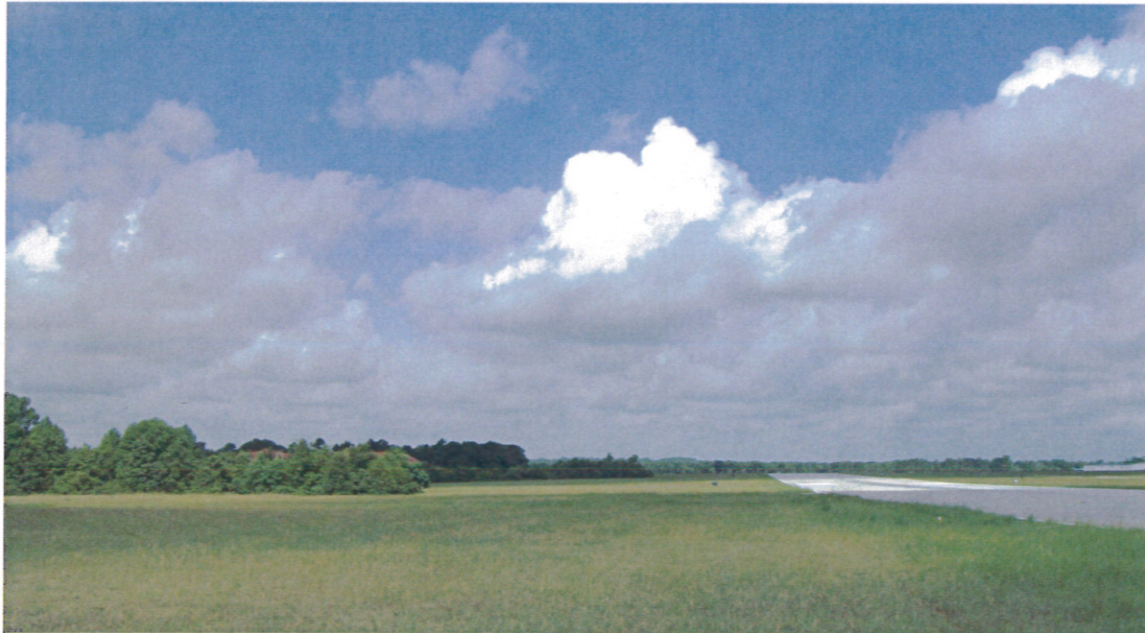
- The primary surface was inspected and found to meet state requirements (See Photo # 4).

Photo # 4 – Primary Surface Runway 10/28

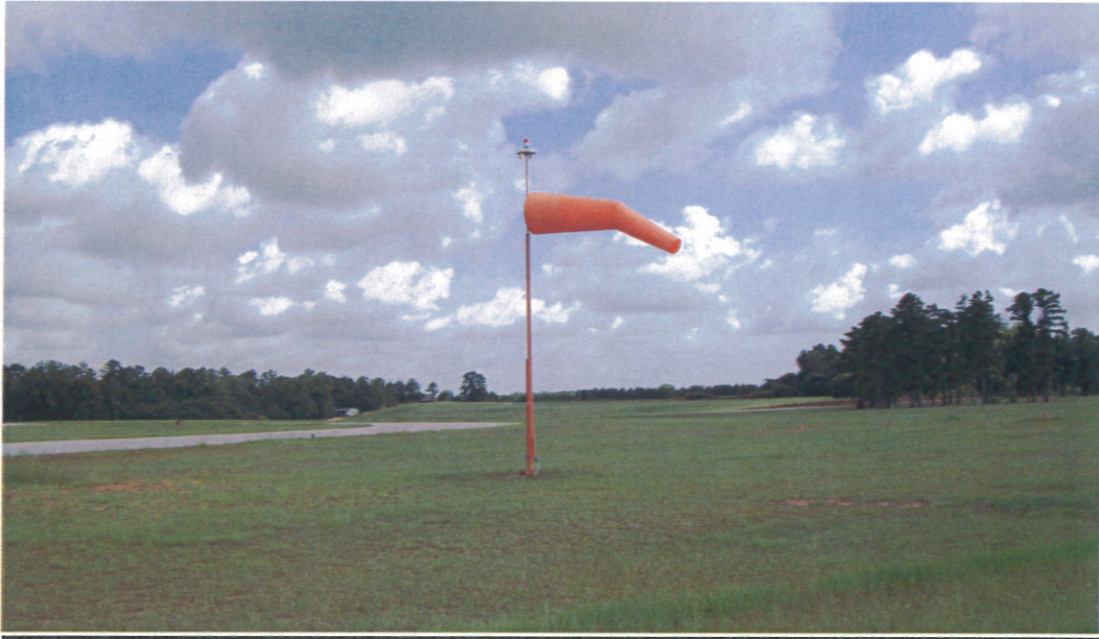
- The wind direction indicator was inspected and complies with state licensing standards (See Photo # 5).

.Photo # 5 – Wind Cone

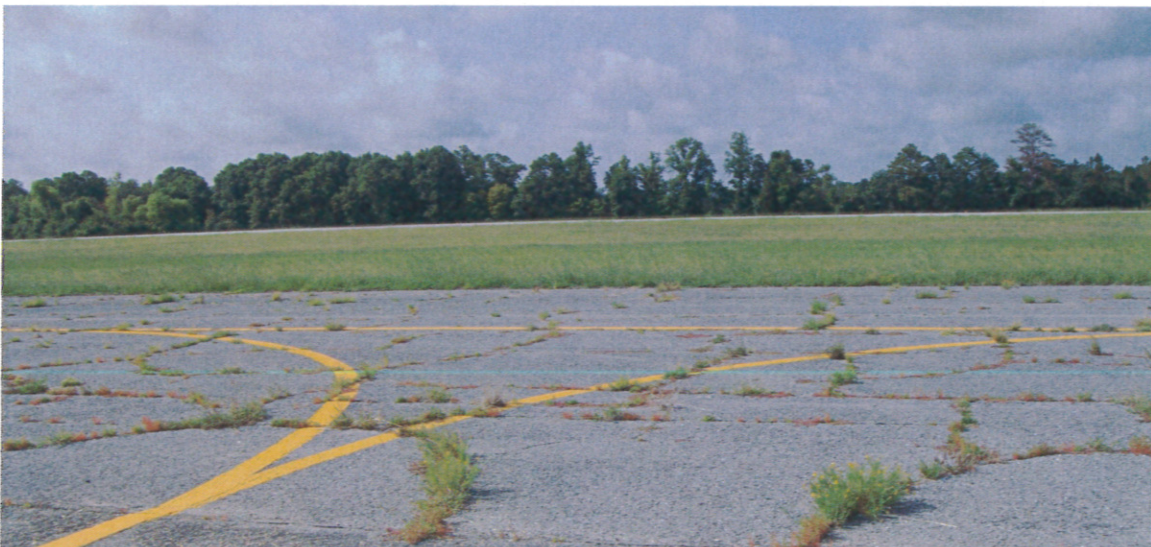
- The airport pavement surfaces were inspected and the runways, apron and parallel taxiway for runway 1/19 were found to be in excellent condition. However, the parallel taxiway for runway 10/28 is in poor condition, containing large blocks with open cracks filled with grass (See Photo # 5).

Photo # 5 – Parallel Taxiway Surface Conditions

- A pavement rehabilitation project for the parallel taxiway for runway 10/28 should be developed. Failure to correct this problem in the near future could develop into a safety hazard.

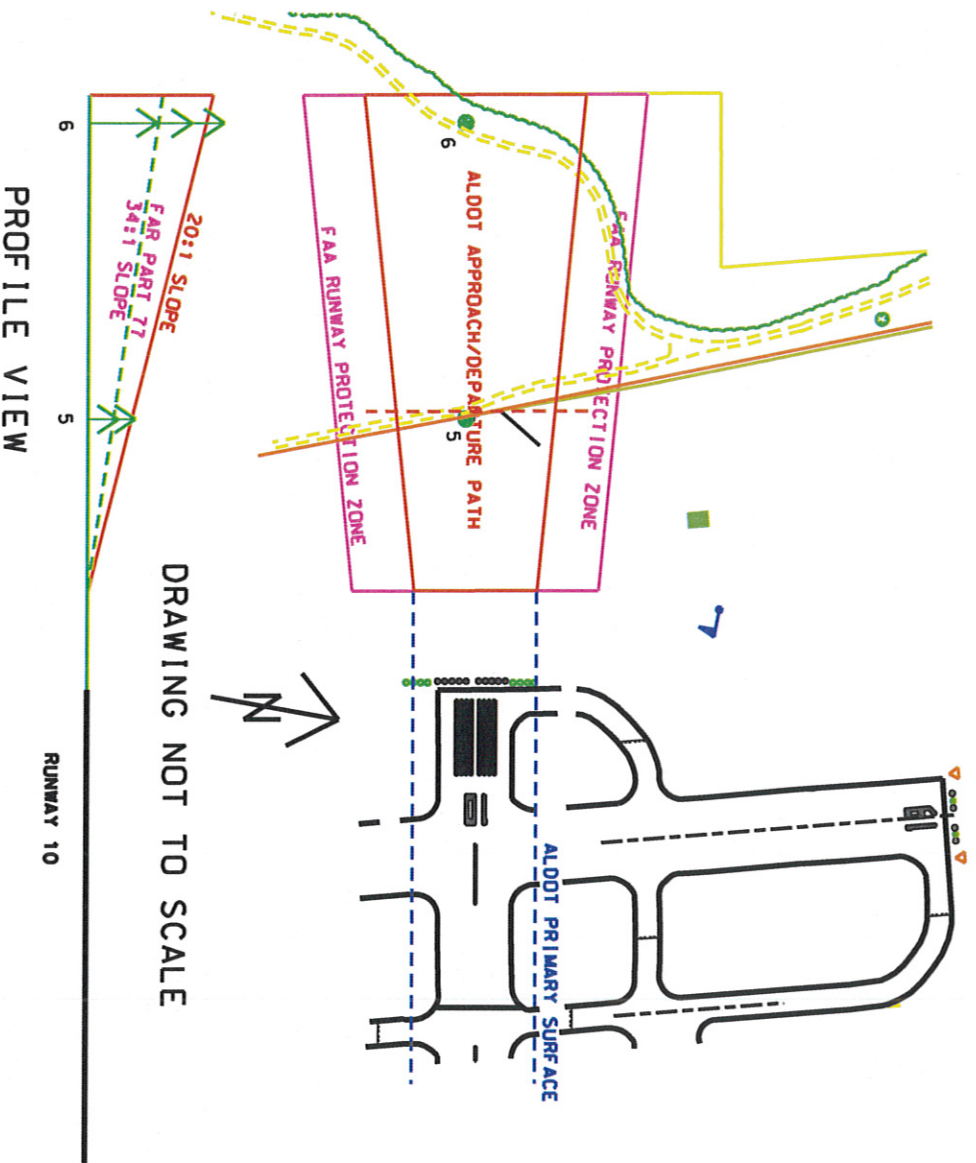
RUNWAY 10

5. TREE - 19' ABOVE RUNWAY END
546' FROM RUNWAY END
20' RIGHT OF CENTERLINE
18:1 OBSTRUCTION CLEARANCE SLOPE
 6. TREE - 55' ABOVE RUNWAY END
1143' FROM RUNWAY END
23' LEFT OF CENTERLINE
17:1 OBSTRUCTION CLEARANCE SLOPE
- NOTES:
1. THIS SKETCH IS PROVIDED FOR INFORMATIONAL PURPOSES ONLY AND SHOULD NOT BE USED FOR ANY OTHER PURPOSE.
 2. REFER TO THE LATEST ALP DATED APRIL 21, 2003 FOR THE FAA AIRPORT DESIGN STANDARDS.

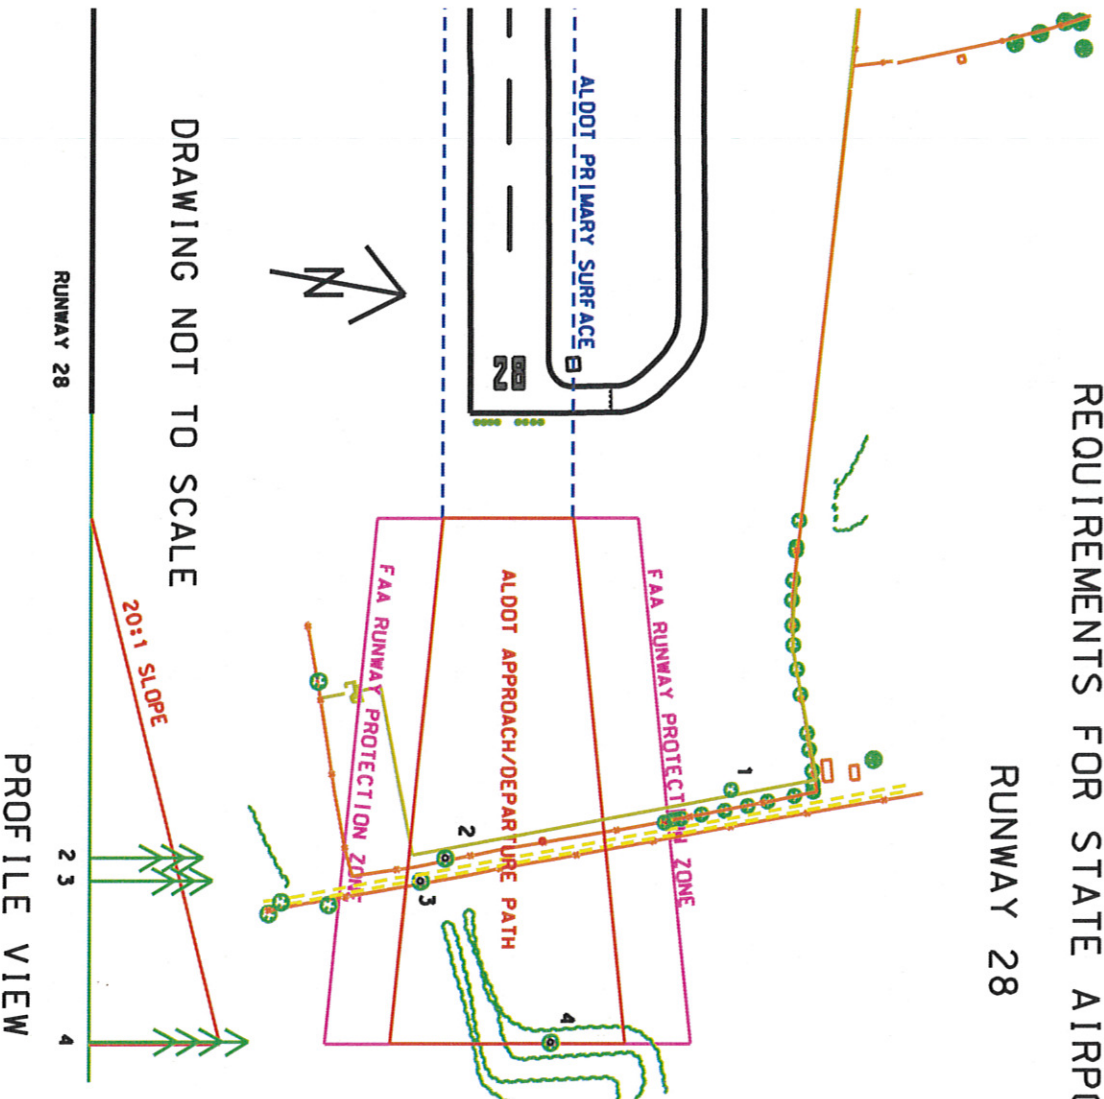
RUNWAY 28

2. TREE - 43' ABOVE RUNWAY END
834' FROM RUNWAY END
120' LEFT OF CENTERLINE
15:1 OBSTRUCTION CLEARANCE SLOPE
3. TREE - 47' ABOVE RUNWAY END
906' FROM RUNWAY END
167' LEFT OF CENTERLINE
15:1 OBSTRUCTION CLEARANCE SLOPE
4. TREE - 61' ABOVE RUNWAY END
1200' FROM RUNWAY END
84' RIGHT OF CENTERLINE
16:1 OBSTRUCTION CLEARANCE SLOPE
